BERNIER CONSTRUCTION, INCORPORATED PROJECT SUMMARY

Project Title: Gas Line Installation Project, VA Hospital

Location: Coatesville, PA

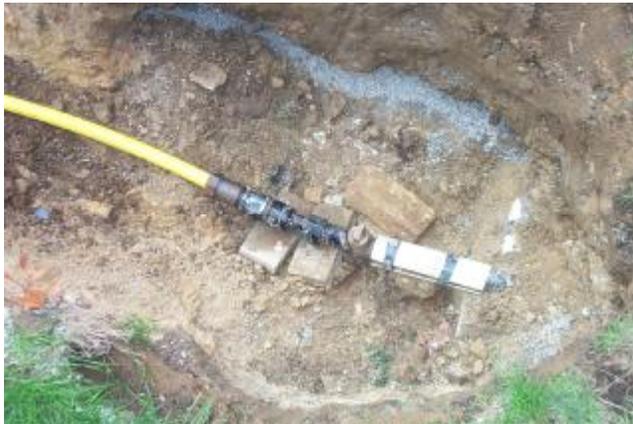
New Gas Line Tie into Existing 1-inch Valve

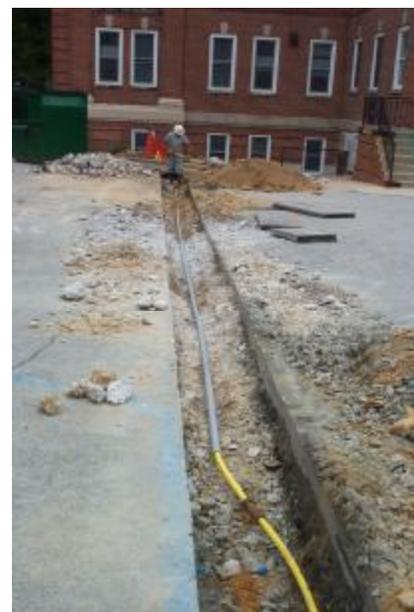
Gas Line Installed in PVC Conduit

The new 1-inch pressure rated gas pipe was installed between 14 and 18-inches below grade. Approximately 50-feet of the new gas line north of Bldg. 1 was encased in 1 ½-inch PVC conduit due to the presence of concrete debris in that area. Once the installation activities were complete the areas were restored to their original condition.
