## **BERNIER CONSTRUCTION, INCORPORATED PROJECT SUMMARY**

**Project Title:** Matteo Iron and Metal, Inc. Superfund Site – Removal Action

**Location:** Thorofare, Gloucester County, New Jersey

**Scope:** Project management services for the removal action at the Superfund site

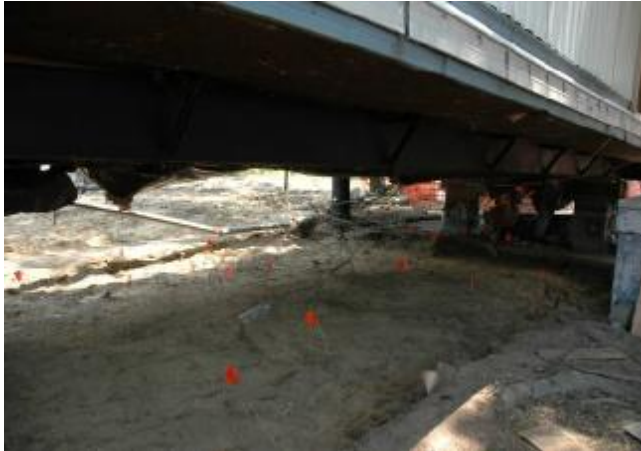
### **XRF Screening Locations under a Raised Mobile Home**

and changes instituted. The second removal action conducted voluntarily by the property owner included the excavation, removal, and disposal of surficial lead contaminated soil from the site and the adjoining mobile home property. Berner Construction utilized a hand held x-ray fluorescence (XRF) meter that provided rapid, on-site measurements of metals contamination in soil to screen the excavations prior to collecting confirmation soil samples for laboratory analysis. The XRF meter results showed good correlation with the laboratory results and subsequently saved the client time and money during the soil removal action. The site and mobile home park were restored to original conditions.

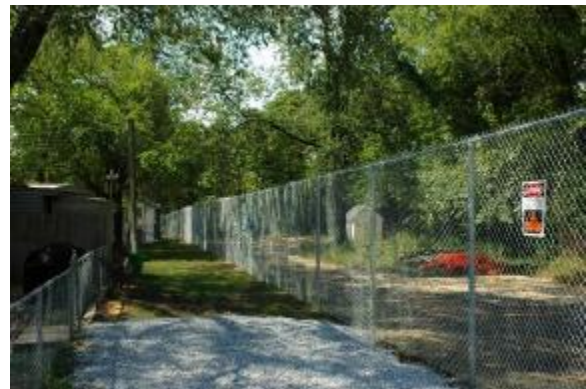
### **New Posted Fence along the Matteo Property Line**

Two separate removal actions were conducted concurrently at the Matteo site between May 2006 and July 2006. The first removal action conducted in accordance with the AOC included a complete property survey, installation of a new fence along the property line to prohibit unrestricted access, implementation of engineering controls and operational changes at the scrap yard to restrict access and direct contact by customers/general public to contaminated areas, and the preparation and implementation of a maintenance plan for the controls
