BERNER CONSTRUCTION, INCORPORATED PROJECT SUMMARY

Project Title: Darlington Lake Northwest Abandoned Mine Land Reclamation Project

Location: Darlington Township, Beaver County, PA

Scope: Provide labor, materials, equipment, and supervision to reclaim an abandoned strip coal mine area

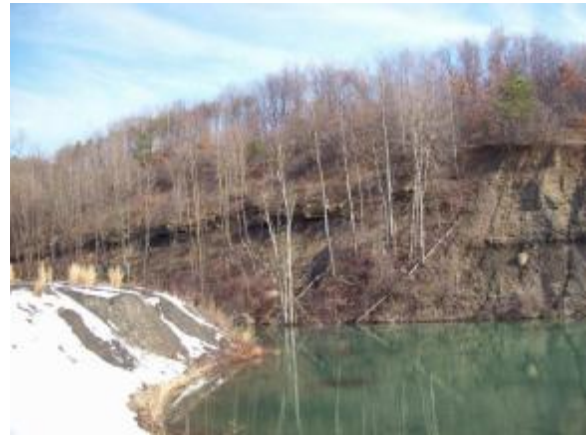
Initial Site Conditions

The project included the installation of 2,400 linear feet of rock lined channels, construction of brush piles for small animal habitat, and the installation of permanent storm water diversion swales. Approximately 1,167,000 cubic yards of displaced materials from the mining operation were used to backfill and grade over 5,000 linear feet of highwall on the abandoned mine site. The dangerous highwalls were over 80 feet tall and were a safety hazard to the community.

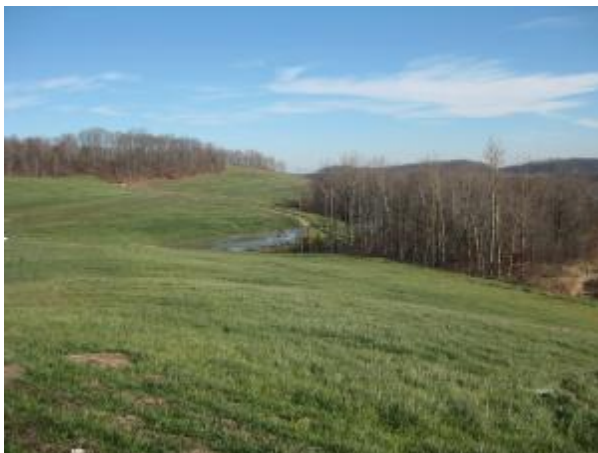
Final Site Conditions after Restoration

The final site restoration involved replacement of a 3 acre wetland area, planting 6,800 trees, and seeding, fertilizing, and mulching 110 acres of restored area.

Berner's Caterpillar D-11 and D-10 bulldozers were used to perform the soil grading operation. The D-10R bulldozer is equipped with a TopCon GPS system to maintain the proper grades through the duration of the project.
