BERNIER CONSTRUCTION, INCORPORATED PROJECT SUMMARY

Project Title: Taylor Borough Abandoned Mine Reclamation Project

Location: Taylor Borough, Lackawanna County, Pennsylvania

Scope: Provide labor, materials, equipment, and supervision to reclaim an abandoned strip coal mine area

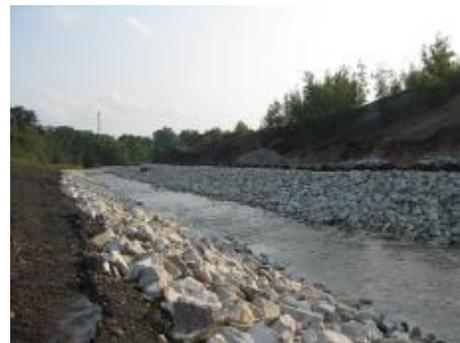
Completed Keyser Creek Channel

As required by the project sequence, the reconstruction of section of Keyser Creek that transversed the site was initiated prior to the start of intrusive activities at the site. Approximately 17,500 tons of rip rap was placed to rebuild the channel.

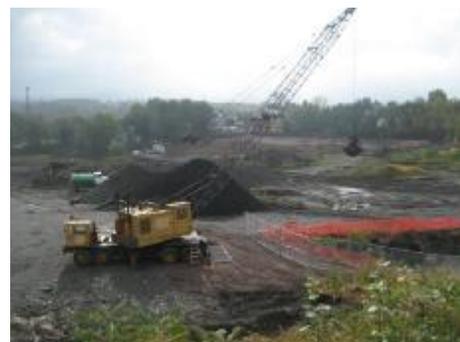
A crane with a clam shell bucket was used to clear and then backfill the abandoned vertical mine shaft on the site. Over 800 cubic yards of material was removed using the clam shell. The shaft was then backfilled with suitable material from the site using the clam shell bucket.

Clearing Blockage from Mine Shaft
