BERNIER CONSTRUCTION, INCORPORATED PROJECT SUMMARY

Project Title: Dam Repairs and Restoration at Willow Grove Naval Air Station Joint Reserve Base (NASJRB)

Location: Willow Grove, PA

Scope: Restoration of stormwater runoff swales; dam repair; installation of emergency spillway, box culvert, and pond aeration system

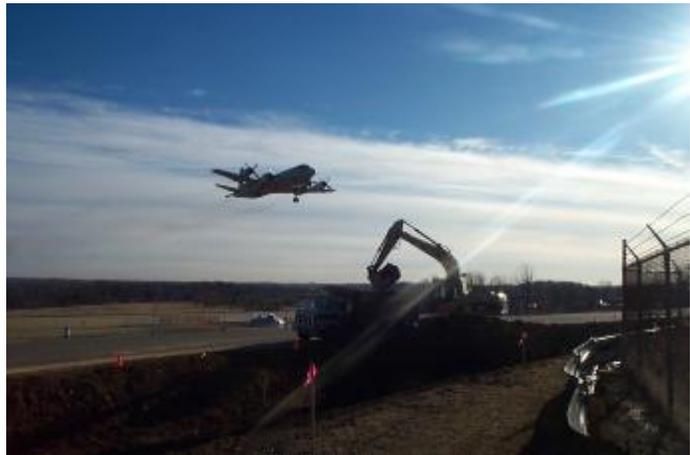
The Willow Grove NASJRB project was implemented in three phases. The first phase included restoration of the existing stormwater runoff swales. The goal of this phase of the project was to modify the swales to comply with current stormwater management design standards since the original swales were undersized. The project scope included the excavation of 4,000 cubic yards of soil, replacement of the topsoil, placement of 2,000 tons of rip rap material for energy dissipation, and the installation of 24,000 square feet of erosion control blanket.

Stormwater Swale Restoration

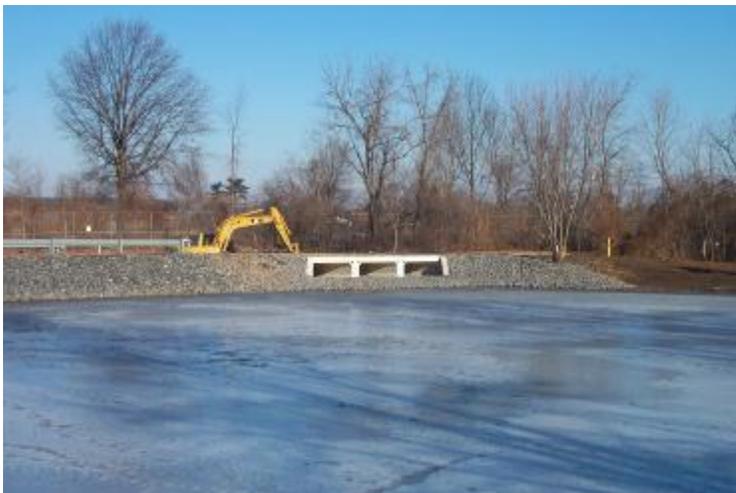
The second phase included repairs to the existing dam. The dam was damaged during a storm in 2001. This project was to implement the dam repairs following an engineering design that included restoration of the dam breast, emergency spillway, and aeration system. Bernier Construction performed the excavation and construction of the emergency spillway that included placement of 8,200 tons of rip rap for spillway protection. 1,500 tons of armor rock and 4,500 tons rip rap protection were placed on the dam breast. The project also included the installation of a 180-ton, segmented, post-tension box culvert.

Dam Repair and Box Culvert Installation
